**Flood Control Project Maintenance
Levee Inspections**
LMA District Cover Sheet
Spring 2018 Levee Inspection Results

Sacramento River West Side Levee District

Spring 2018 Levee Inspection Results

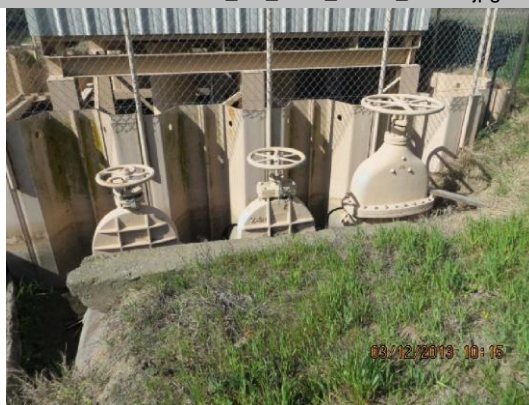
Photo 3 of 3 : UCIP_SP_2018_10087_17233.jpg

Slide gates at pumphouse on LS toe.

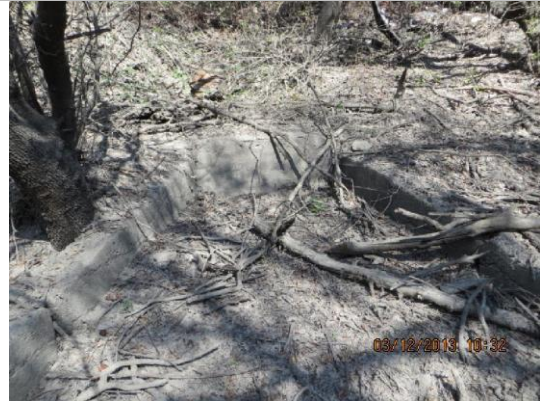
Photo 1 of 1 : UCIP_SP_2018_10088_17237.jpg

LM Start	0.22	Rating **	A/W	Issue No.	1554	
LM End	0.22	Issue Type +	Ma	Location *		
Category	Supplemental			GPS Latitude/Longitude		
				Start	End	
Item	DWR UCIP LMA Responsibility			38.802293 °	38.802293 °	
				-121.724847 °	-121.724847 °	
DWR ID						
Comment Code						
Inspector Comment						
FS_ID:10088						
DS_ID:20327						
EP_NO: N/A						
Repair Type: No Action Needed						
Crossing Status: Found						
UCIP Comments:						
FIELD_STRUCT_DESC: *ABANDONED* 42-inch drainage pipe of an unknown material through the levee, 28.5 feet below the crown.						
Abandoned in place by plugging with concrete. Headwall on waterside (WS) toe. [Additional Reference(s): USACE Sacramento O&M Manual 130, May 1960 (HLM 0.22)].						
FS Date: 3/12/2013

Concrete headwall visible on WS toe.

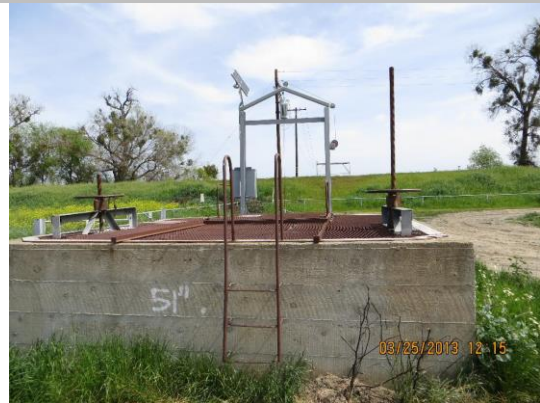
Photo 1 of 3 : UCIP_SP_2018_10103_17262.jpg

Comment Code					
Inspector Comment					
FS_ID:10103 DS_ID:20226 EP_NO: 1331 Repair Type: Non-Urgent Crossing Status: Found UCIP Comments: There is no gate in the slide gate at the concrete distribution box off the landside toe. This may not be an issue as there is a slide gate at the WS toe. FIELD_STRUCT_DESC: 54-inch corrugated metal irrigation pipe through the levee, 28 feet below the crown. Vertical pumps on a pile structure in the stream. Walkway to pumps. Flap gates from pumps and slide gate inside a 7-foot by 10-foot concrete surge box on the waterside (WS), 1948 installation. 15-foot by 18-foot concrete distribution box 150 feet off landside (LS) toe with slide gate. (Permit No. 1331, 1948 - River Farms Company of California). [Additional Reference(s): DWR Levee Log, 2006. USACE Sacramento O&M Manual 130, May 1960 (HLM 0.47)]. FS Date: 3/25/2013 7:36:51 AM

Concrete distribution box on 150-feet off landside toe.

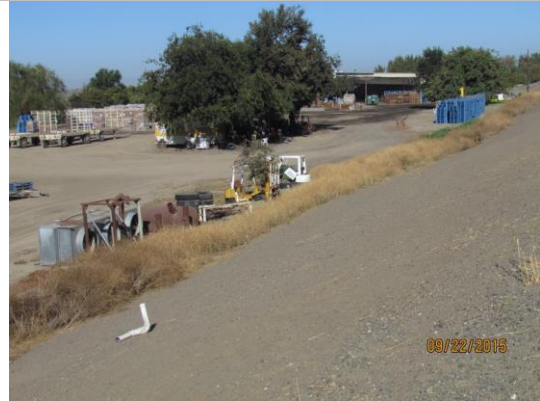
Photo 2 of 2 : SP_2018_NA0016_435_1550_20180306_00083.jpg

View of the machinery along the landward levee toe looking upstream. Fall 2015.

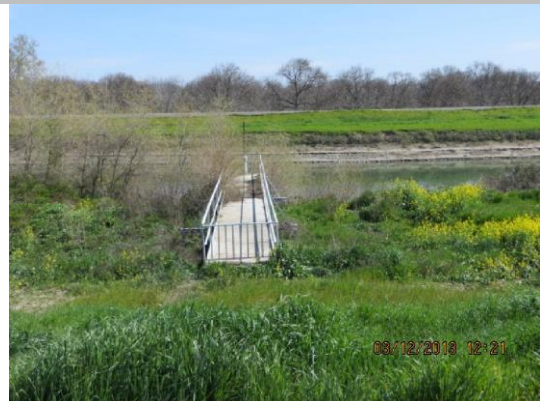
Photo 1 of 3 : UCIP_SP_2018_10125_17283.jpg

Steel walkway on WS berm with Slide gate actuator.

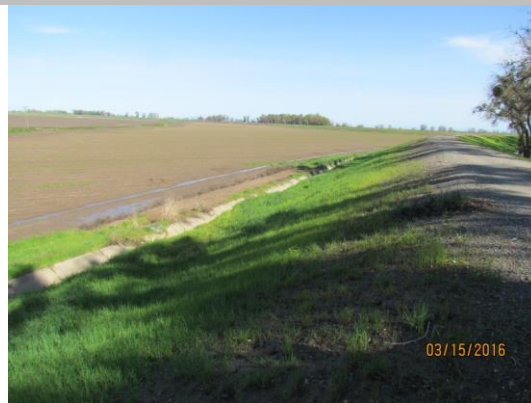
Photo 1 of 1 : SP_2018_NA0016_435_8_20180306_00007.jpg

View of the ditch on the landward side of the levee looking upstream.
Spring 2016.

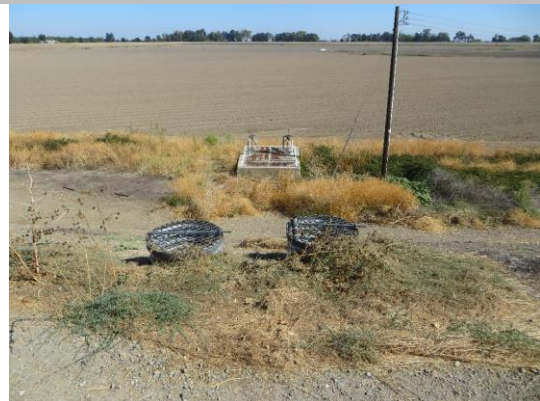
Photo 2 of 3 : UCIP_SP_2018_46766_74706.jpg

FS_ID:46766
 DS_ID:25126
 EP_NO: 8501
 Repair Type: Non-Urgent
 Crossing Status: Found
 UCIP Comments: a few actions are recommended based on field inspection: 1. clear out metal fence posts near daylight of pipe on water side levee. 2. clear vegetation around pipes on water side of levee to aid in inspection. 3. monitor burrowing activities on water side of levee.
 FIELD_STRUCT_DESC: 2 of 2: 20-inch steel irrigation pipe, at an unknown depth, and 16-inch steel irrigation pipe, at an unknown depth, are located at levee mile 6.889 and 6.89, respectively. Both pipes have a protective paint coating. The pipes are used to supply irrigation water to the adjacent fields. On the waterside (WS) of the levee, the pipes are above ground and follow the slope of the bank into the river. A metal pump house, supported on a steel frame, is located on a bench on the WS of the levee. When the pumps are operational, a drum fish screen is lowered over the pipe intakes on a track. Both irrigation pipes travel through the levee and have siphon breakers inside corrugated metal riser units on the landside (LS) crest of the levee. The pipes discharge under submerged conditions to a 9.5-foot by 12-foot concrete distribution box. There are two gated outlets on the distribution box that lead to distribution canals.

view from levee crest along pipe looking towards land side. shows siphon breaker standpipes and distribution box.

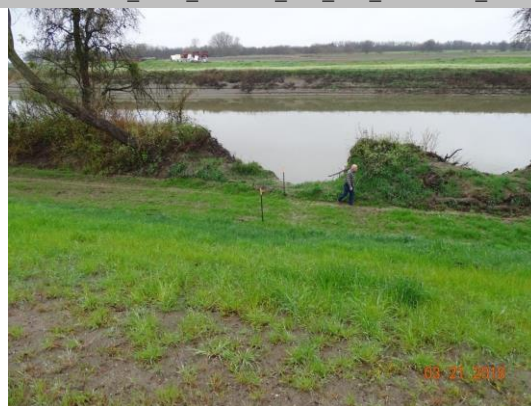
Photo 1 of 3 : SP_2018_NA0016_435_112_20180326_00250.jpg

View of the berm where the oak tree used to stand, facing the Sacramento River. Spring 2018.

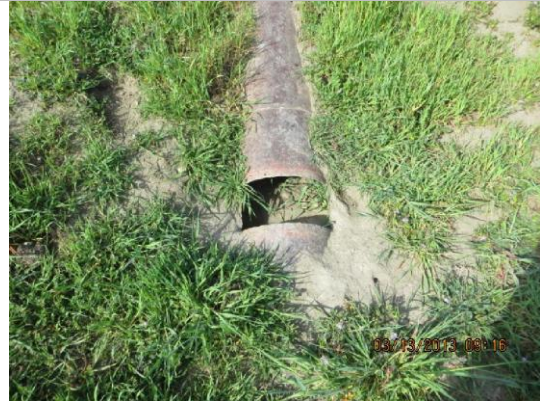
Photo 3 of 3 : UCIP_SP_2018_50039_17326.jpg

Pipe open where watermeter was removed.

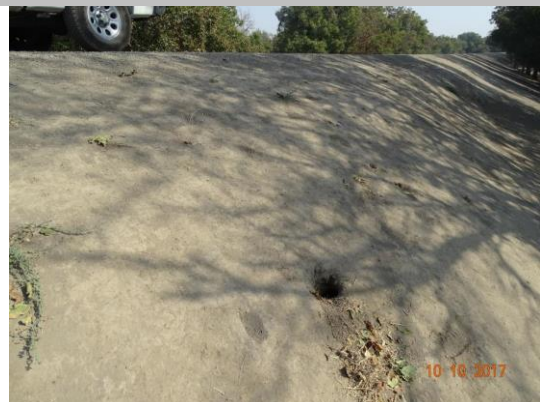
Photo 1 of 2 : SP_2018_NA0016_435_226_20180306_00077.jpg

View of rodent burrow halfway down landside slope. Fall 2017.

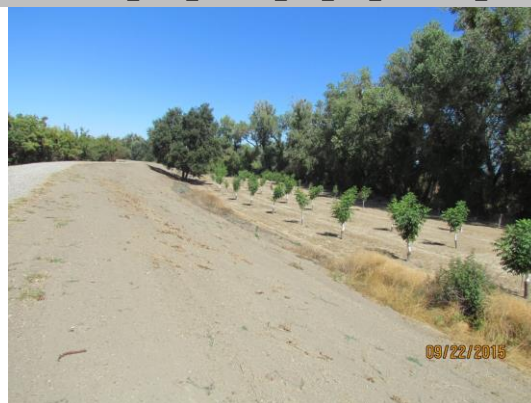
Photo 1 of 1 : SP_2018_NA0016_435_966_20180306_00081.jpg

View of the walnut orchard planted on the waterward side of the levee looking upstream. Fall 2015.

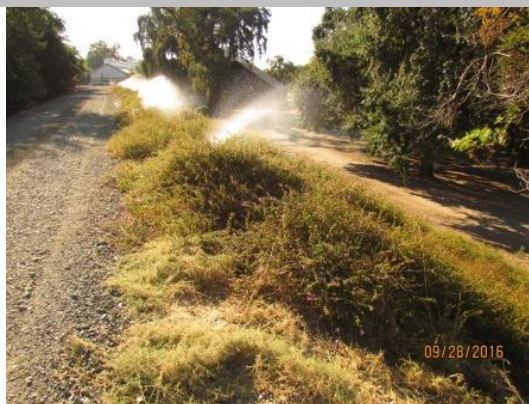
Photo 2 of 2 : SP_2018_NA0016_435_173_20180306_00075.jpg

Irrigated landscaping on landside slope of the levee reaching levee crown. Fall 2016 inspection.

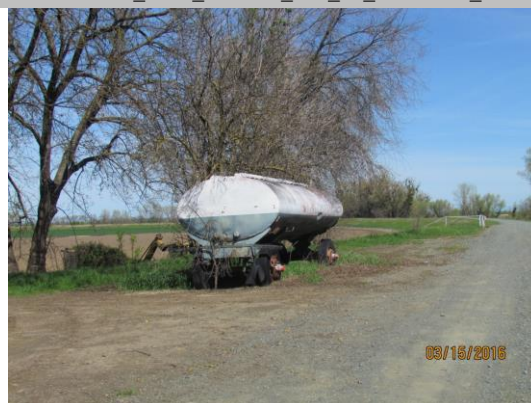
Photo 2 of 2 : SP_2018_NA0016_435_26_20180306_00018.jpg

View of the equipment on the crown of the levee looking upstream.
Spring 2016.

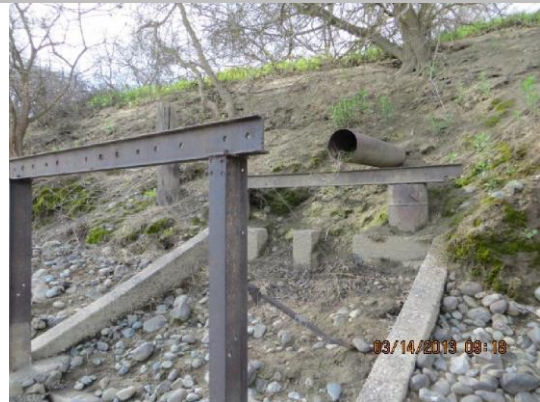
Photo 3 of 3 : UCIP_SP_2018_10261_17464.jpg

abandoned pump platform on Rivers edge.

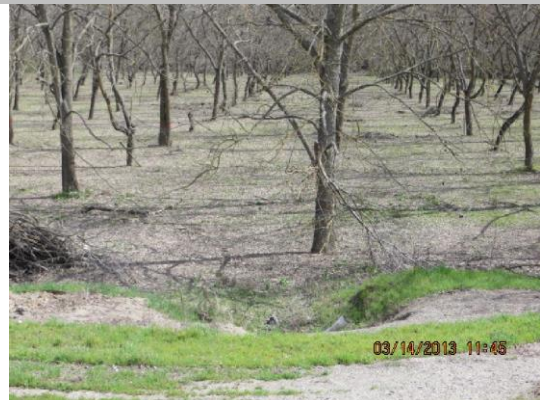
Photo 3 of 3 : UCIP_SP_2018_10291_17546.jpg

Excavation at WS toe where pipe should be.

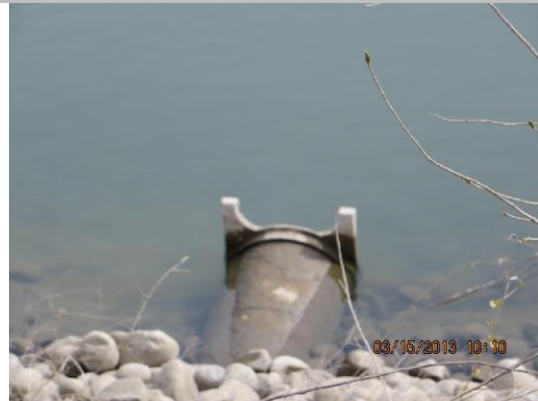
Photo 3 of 3 : UCIP_SP_2018_50042_17585.jpg

Pipe missing flap gate at waters edge.

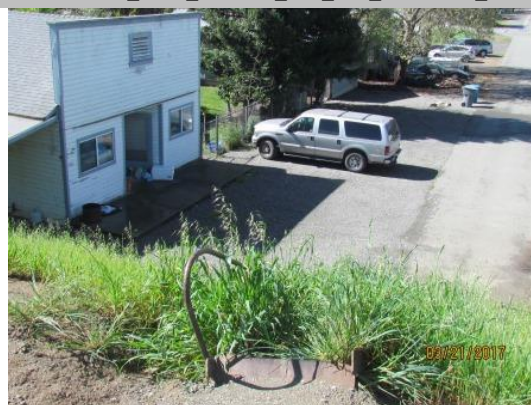
Photo 1 of 1 : SP_2018_NA0016_435_157_20180306_00073.jpg

Permanent metal staircase installed on landside levee slope. Spring 2017.

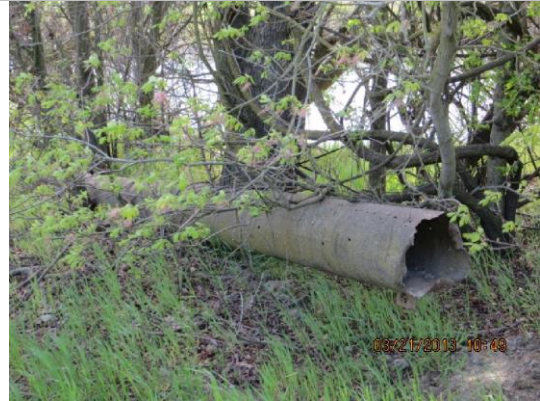
Photo 3 of 3 : UCIP_SP_2018_10528_17852.jpg

12-inch pipe debris on WS berm.

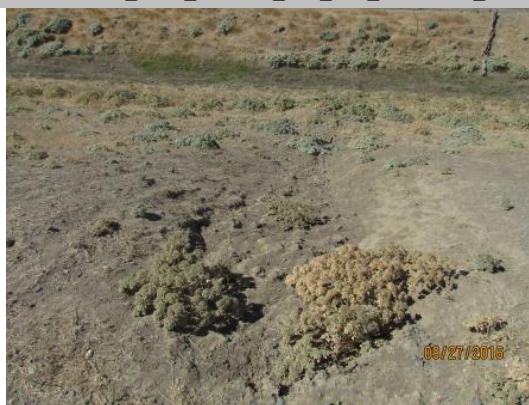
Photo 2 of 2 : SP_2018_NA0016_435_146_20180306_00071.jpg

Slope stability issue due to foot traffic. Fall 2016 inspection.

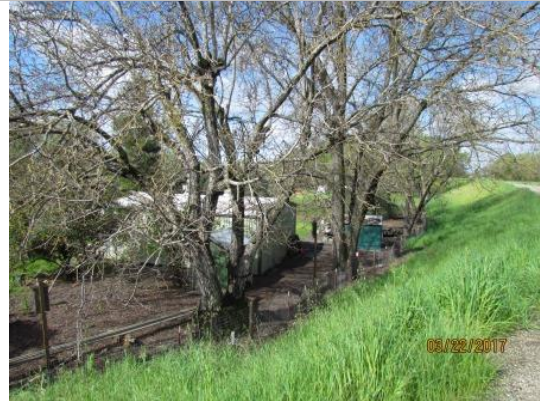
Photo 1 of 1 : SP_2018_NA0016_435_199_20180306_00076.jpg

Fence along landside levee toe blocking access. Spring 2017.
